Wooden Balconies in Andrūn Bhāṭi Gate- *from Bhāṭi Gate to Bāzār-i Ḥakīmān*

Samina Zia Sheikh

Accepted 30 Sept 2015, Available online 11 Oct 2015, Vol.3 (Sept/Oct 2015 issue)

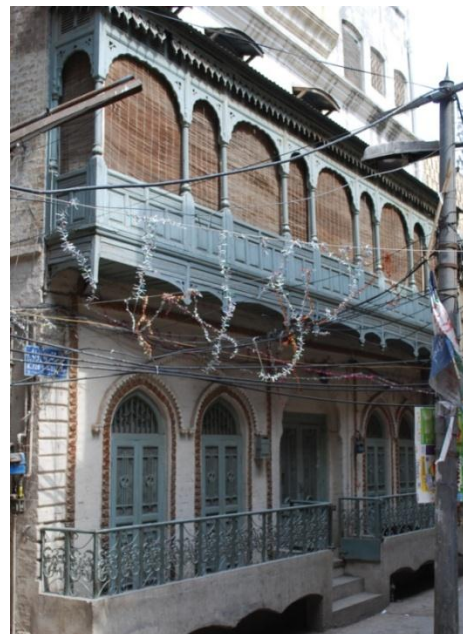
Plate.2 Makhzan House, House # B/217, Muḥallah Islām Khān, Galī Shāir Dil.

Length of the balcony is approximately nine meters and width is 76cm. Height of the balcony from front is 2.43 meters and from the edge attached with wall is 2.59 meters developing 16cm slopping roof. Ceiling of the roof is made of wooden planks joining with the frame of louvers. Wooden bars of louvers are always angled which let light and air come in but keep out rain, straight sunshine, and noise. Whole structure of the balcony is painted in light blue as one of the best ways to protect wood features is standard painting but sometimes disproportionate over layering of paint destroy the details of the delicate wood carvings.

Front of the balcony is divided by five big and four small multi-foil arched openings supported with Chamfered posts. These chamfered posts are redecorated with a vase shaped base. Decorative wood elements such as frieze, fret work or spandrels adorned with visual concentration and are précised to a building's style and period of construction. Spandrels of these chamfered posts are decorated with carved flower and leaves pattern drawn symmetrically on both sides of big openings whereas small openings have three divisions of carved motifs to bring a different design balance. Upper section of these openings has sets of louvers in each section. Bigger openings have four sets and small openings are with two sets of louvers. Above these louvers is saw toothed frieze which is beautifully carved with delicate symmetrical geometric patterns.

Area above frieze is cornice which is divided into two running grooves. Simplicity of the frieze in appearance adds grace to the balcony and brings a balance to the structural design. Furthermore roof of the balcony is covered with corrugated tin sheet to save wood from

weather effects specifically rain water. Though balcony is well preserved but some of the components are deteriorating and require repair and regular maintenance such as joints and decorative fan shaped fringes of projection. Lower section of the columns is fixed balustrade divided by symmetrically set grooved compartments in square and rectangular shapes. Exterior of these compartments is decorated with fine grooves however inner side has flat divisions without any decorative elements and reveals over layering of paint that was applied during years. Sophistication and simplicity in design divisions and motifs applied to balcony add grace to the whole structure and giving it a remarkable appearance.

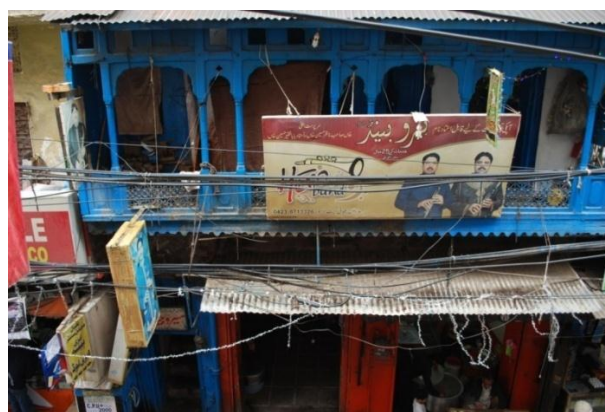
Plate.3 House # 597-B, Andrūn Bhāṭi Gate Bāzār.

This room in west leads to roughly seven meters long wooden balcony richly painted with bright blue colour. Interior of the rooms is also painted in same bright blue.

Though this house enjoys historical importance and is center of interest for visitors but much attention is not paid to preserve the balcony of this house which is the only and the most prominent feature of this small house. Despite the fact that the structure of this wooden balcony is very old many weights are tied with the structure with various ropes. These include framed portraits of musicians printed on small flexes and a big hoarding of Hero band which is fixed in the center of balcony hiding half of balcony's character. One of the most agonizing acts is brutal nailing in this wooden structure to fix main electric wires and some cables. This behavior shows the ignorance of the house owner about the historical value of the house as an important part of our heritage.

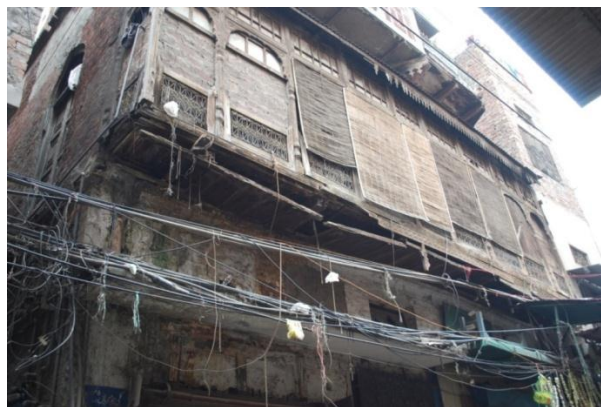
Plate.4 House #6, Galī Jauhriyān(band), Andrūn Bhati Gate Bāzār.

Wooden balcony of House # B-1100-A in Muḥallah Jalūtiān, Galī Jauhriyān (band)^{xxi}, is another example of laxity in preservation of this valuable structure. Wood is neither painted nor polished therefore deterioration due to weather effects is evident. Decay of various features of

the structure is making it a picture of recklessness. Overall structure of the balcony is traditionally divided into openings but symmetry of these sections is different from balconies mentioned before. Central seven arched openings are of equal size however two openings on both ends of facade are smaller than central. Due to this dissimilarity in size of central and side arches the further division of clerestory above on both ends display a different geometrical division. (Plate.4)

Facing façade shockingly two opening on left are closed by constructing brick wall and on its right two sections with wooden planks which makes no sense at all. Traditional cusped arches are supported with polygonal columns with decorative base and capital. Base of these columns possess double lotus bud motif and same lotus bud is applied in capital composed in an upside down manner. Floral section of the base ends on a square section which is adorned with carving with applied motif of star. This way the column involves both geometric and floral patterns in round and relief for adornment that brings diversity in design and makes it more appealing.

Same star pattern is applied in carvings of wooden strips that are adorning the projecting joist beam. It is revealed in the form of a running strip below railing with regular intervals that are created with dividing lines to break continuity of motif. This decorated carved strip is followed by one more parallel strip of carving with quatrefoil pattern. This double decorative strip on the edge of projection is a unique feature of beautification. Carvings on both running strips are intricately done and demonstrate remarkable skill of artisan. Pieces of both decorative strips are no more joined appropriately and with the passage of time gapes have developed which are not mended. Since the balcony is neither painted nor polished therefore moisture accumulation at joints weakened the grip of structural components. This is the clear reason that various elements lost grip and structural damage occurred. Many pieces of lower quatrefoil patterned strip are missing and the underside of the balcony flooring is also scantily damaged. Wooden planks of underside of balcony are hanging down from their original position which is somehow very dangerous. A vertically hanging wooden bar with remains of fringes is the only evidence that projection may have regular fringe ornamentation which is completely disappeared.

An additional exclusive feature of this balcony is double clerestory, first above arches and the other developed with a wooden frame in between cusped area of arches. Spandrels display carved rosettes which give grace to the surface. Frieze above clerestory is adorned with delicate geometrical fringe made of thin wooden strips which partly remains rest destroyed. This delicate

It is important to ensure a high level of conservation of these existing balconies before they lose remaining features. Either a financial assistance to residents should be provided or some valuable strategy can be set to educate people about the value of such structures.

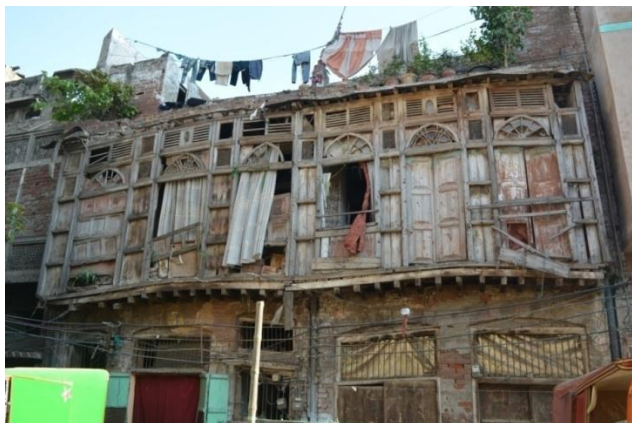
Plate.5 House # 388-B, Mūhallah Chawmālān, Andrūn Bhāti Gate.

House is in a very dreadful condition, it has turned to be ruined due to settlement from foundations which can be clearly seen in the disposition of brickwork of walls. This settlement of soil has dilapidated complete structure included its balcony. (Plate.5)

Wooden balcony of this house is characteristically unique in style but completely frayed though residents are daringly using it. None of the components are in good condition, nonetheless, basic image of the structure shows symmetry with seven small divisions and six big but in most of the parts symmetry is lost due to alterations. Now it represents a combination of various designs due to alterations that are made with the course of time. Openings of this nine meters long balcony are trabeated in style, showing windows and doors. One door is secured by fixing wooden bars but broken from lower quarter which is traditionally fixed with balustrade, though; none of such security measures are taken for the other door. Two other sections are fixed in bistrā style with movable wooden planks which is a known Kashmiri design.^{xxii} These wooden planks are in shreds though in actual design they are adjustable and can be moved and fixed to control the required amount of wind and light.

Above these openings clerestory is designed in arc shape following geometrical patterns in wooden framework. A conscious effort of symmetry is evident while bringing variation in design. Very few pieces of glass remain in

clerestory and most of them are missing. Louvers of structure follow two variations of designs but every section is frayed. Most of all the beam joist is also dilapidated and whole structures seems to be ruined. Wooden planks of ceiling are absent and most of the area is only covered with tin sheet. A reason of heritage loss in Walled City is rapid economic conversion. Andrūn Bhāti Gate Bāzār has shops on the ground floor and residential quarters above. Most of the residents are not owner rather tenants. They are least bothered about the repairs and maintenance of the buildings. Economical change often wins out over the consciousness of cultural heritage preservation. Buildings have been modernized or altered to fulfill the requirement of economical growth. Even at national level departments working for heritage protection do not give assurance that a major cultural asset will live to tell the tale. The enduring global profits of cultural heritage are often low-priced against openings for instant domestic economic development. Instead of conservation of valuable heritage many historical features are torn down for modern constructions and what is left is not preserved carefully. Remaining living heritage is neglected or surrounded by inadequately designed commercial development. This commercial development has brought irreversible loss to the heritage.

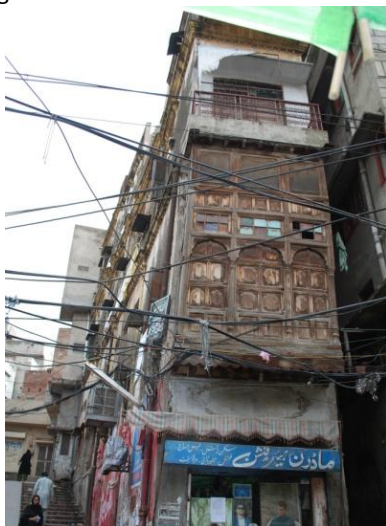
Plate.8 House # 2117-A, Kūcha Mūnshī Ladhha, Andrūn Bhāti Gate Bāzār.

Hāji Jamshaid Chaththa owner of House # 2115-A, in Kūcha Mūnshī Ladhha, also possess ownership of House # 2117-A. Daughter of Hāji Jamshaid Chaththa is living on ground floor while above stories of the house are given on rent. Façade of this house is also decked out with same bistrā style wooden balcony. This building is popularly known as 'Leaning Tower of Bhāti Gate', because the whole structure of the building has leaned to one side. (Plate.8) Balcony of this house displays similar design on exterior with few minute variations but the most annoying experience was the inside situation of the room from where the balcony is accessed. House lady has blocked the accessed to the balcony by fixing a huge cupboard in front of it. This kind of behaviour clearly shows the negligence of people about the value and function of this historical structure.

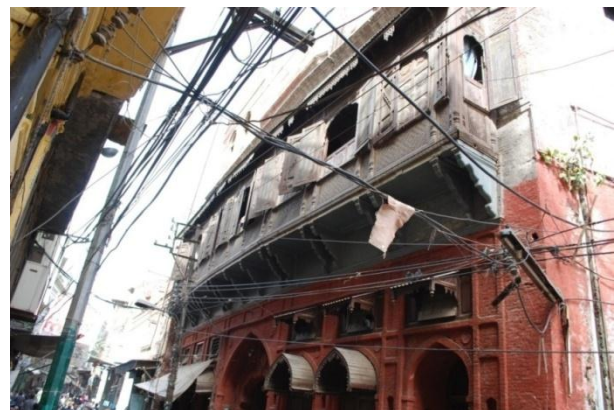
Plate.9 Lāl Havelī, Plot # 11/H, 1237 in Bāzār-i Ḥakīmān.

Visually captivating balcony is projecting the taste of maker and the owner of the house. It embraces unique features in which basic structure is following traditional bistrā style with movable wooden planks in between openings, additionally these multi-foiled arched openings are holding windows of metal mesh with decoratively design framework. Arches are supported with fluted columns with traditional lotus base and capitals and spandrels are decorated with conventional sunflower motif. At the same time all movable wooden planks between arched openings are decorated with carved octofoil pattern. Another remarkable decorative feature is its balustrade. It displays stencil carving, known as pinjrā work,^{xxv} with précised geometrical sections making patterns. This ornamentation shows remarkable skill of the artisan. Same ornamental work is applied above arched openings. This kind of incredible skill shows, there once was living a community who was dedicated to such artistic pursuits. This was the contribution of those master builders and skilled craftsmen who added grace and magic of such creations. And expressed and depicted the soul of society, religion and nature.

from insects and bugs specially house flies and mosquitoes that cause various diseases. These metal mesh windows are formed with geometrical design within the frame that gives strength and support to the mesh. Hinge joints of some windows are broken and need repair. Some other damages are also evident in the structure such as fringe adorning the cornice.

Balcony is in good condition and all of its components are in order. Movable planks of openings have sets of hooks to fix these planks, both on sides and upper section. All components are in working condition which shows the regular maintenance of the structure.

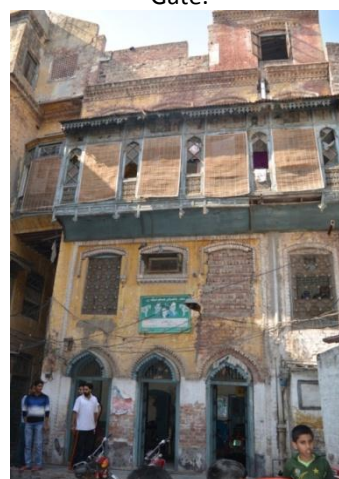
Plate.11 House# A-400, Jaugī Muḥallah, Andrūn Bhāti Gate.

Balcony of House # A-400 holds a different scheme of stained glass application. (Plate.11) Stained glass is not only applied on clerestory, it is also applied on small sections between openings above balustrade. Many pieces are damaged and many sections have completely lost coloured glass. A very simple geometrical scheme is applied to fix these coloured glass pieces in wooden frames set in small sections of openings.

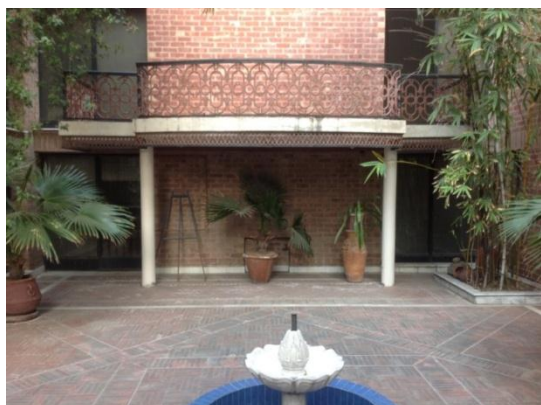
Plate.12 Swiss Avenue, Ahshiyana, 72-B, Gulberg-3, Lahore.

While surveying various structural loss and damages of wooden balconies in Andrūn Bhāti Gate I noticed that the culture which is vanishing so fast from the area it belongs is transferred in modern houses. People who have knowledge and taste are adding components of old architectural tradition in their newly built houses. One such example is the house of Saleem Jilani, an engineer by profession, resident of Swiss Avenue, Āhshiyāna, 72-B, Gulberg-3, Lahore. (Plate.12)

Backyard of house is adorned with many architectural components brought from old houses of various area of tradition. These components include old doors, balcony balusters etc. He said, "Balustrade of the backyard balcony was once a part of house at Jain Mandir, I bought it when house was demolished and installed it in my newly designed balcony."^{xxvi} Same application is seen in various parts of house and now the building is a fusion of tradition and modernity.
